Minerals Inspection Report

Mine Name: Limelight Green Quarry	Permit Number: S/003/0012	Mine Status: Reclaimed
Operator Name: Northern Stone Supply	Inspection Date: 06/10/2014	Permit Fees: No Fee Req.
Inspector(s): Lynn Kunzler	Inspection Time: 1:00 pm	Bond Amount: \$20,000
Attendee(s):	Weather: clear	Bond Escalation: NA
Inspection Purpose: evaluate revegetation success		Prior Inspection: 8/8/2012

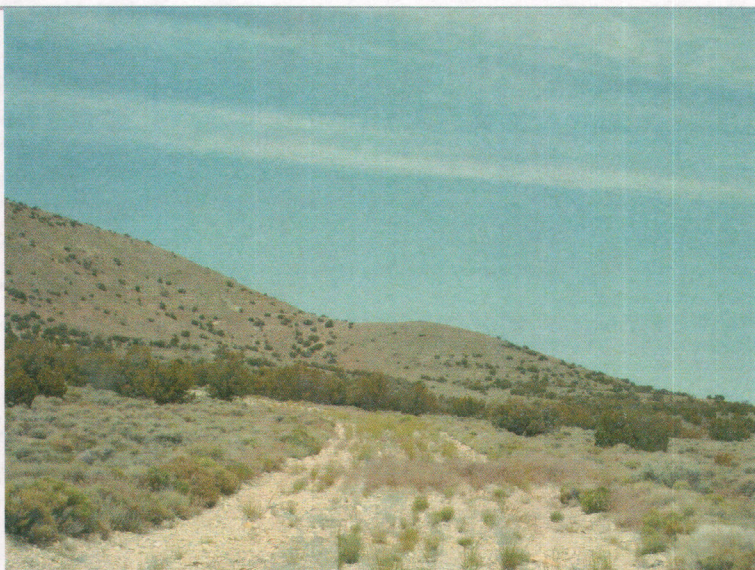
5. <i>Roads (maintenance, surfacing, dust control, safety)</i>	<input checked="" type="checkbox"/>	<input type="checkbox"/>
All roads associated with this project have been reclaimed.

Reclaimed access road
